BUREAU OF RECLAMATION  
HYDRAULIC LABORATORY

HYDRAULIC MODEL STUDIES OF NAVAJO DAM  
SPILLWAY AND AUXILIARY OUTLET WORKS  
JUNCTION WITH THE SPILLWAY

Hydraulic Laboratory Report No. HYD-458

November 14, 1961

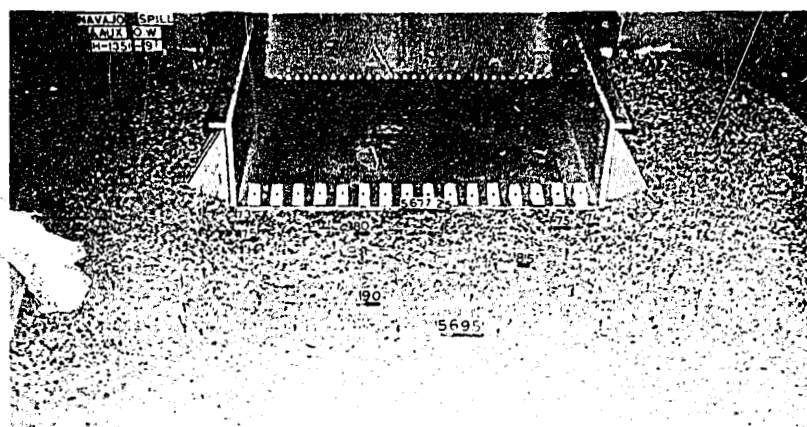
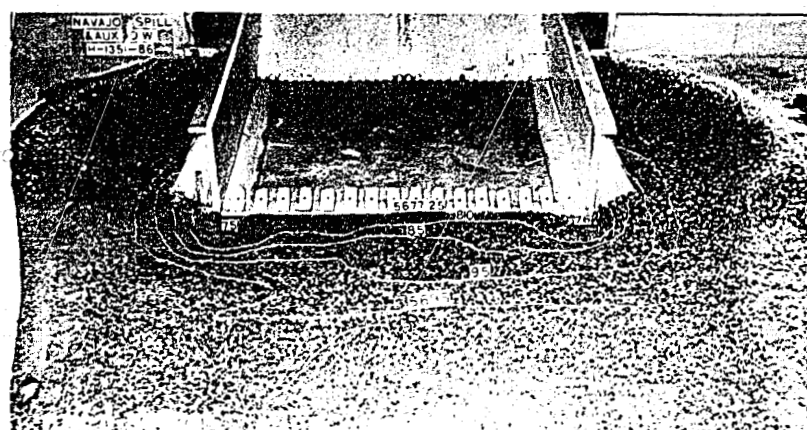
A. Erodible bed before each test.

B. 4-1/2-hour test  
34,000 cfs  
tailwater elevation 5723

C. 4-1/2-hour test  
34,000 cfs  
tailwater elevation 5715

NOTE: Erodible bed was a sand bed riprapped with a 3/4-inch layer of 1/2-inch gravel to represent the proposed 3-foot layer of riprap composed of 24-inch stones.

NAVAJO DAM SPILLWAY  
Erosion Tests--Preliminary Basin With Riprap  
1:48 Scale Model

The erosion test was repeated using a 3/4-inch layer of gravel over a sand bed (Figure 37). This represented a 3-foot-thick layer in the prototype. The gravel had maximum length dimensions of between 1/2 inch and 3/4 inch, which represented 2- to 3-foot lengths in the prototype. After a 4-1/2-hour model test with either high or low tail water, minor erosion occurred at the downstream corners of the stilling basin and along the top of the right bank of the discharge channel (Figures 37B and 37C).

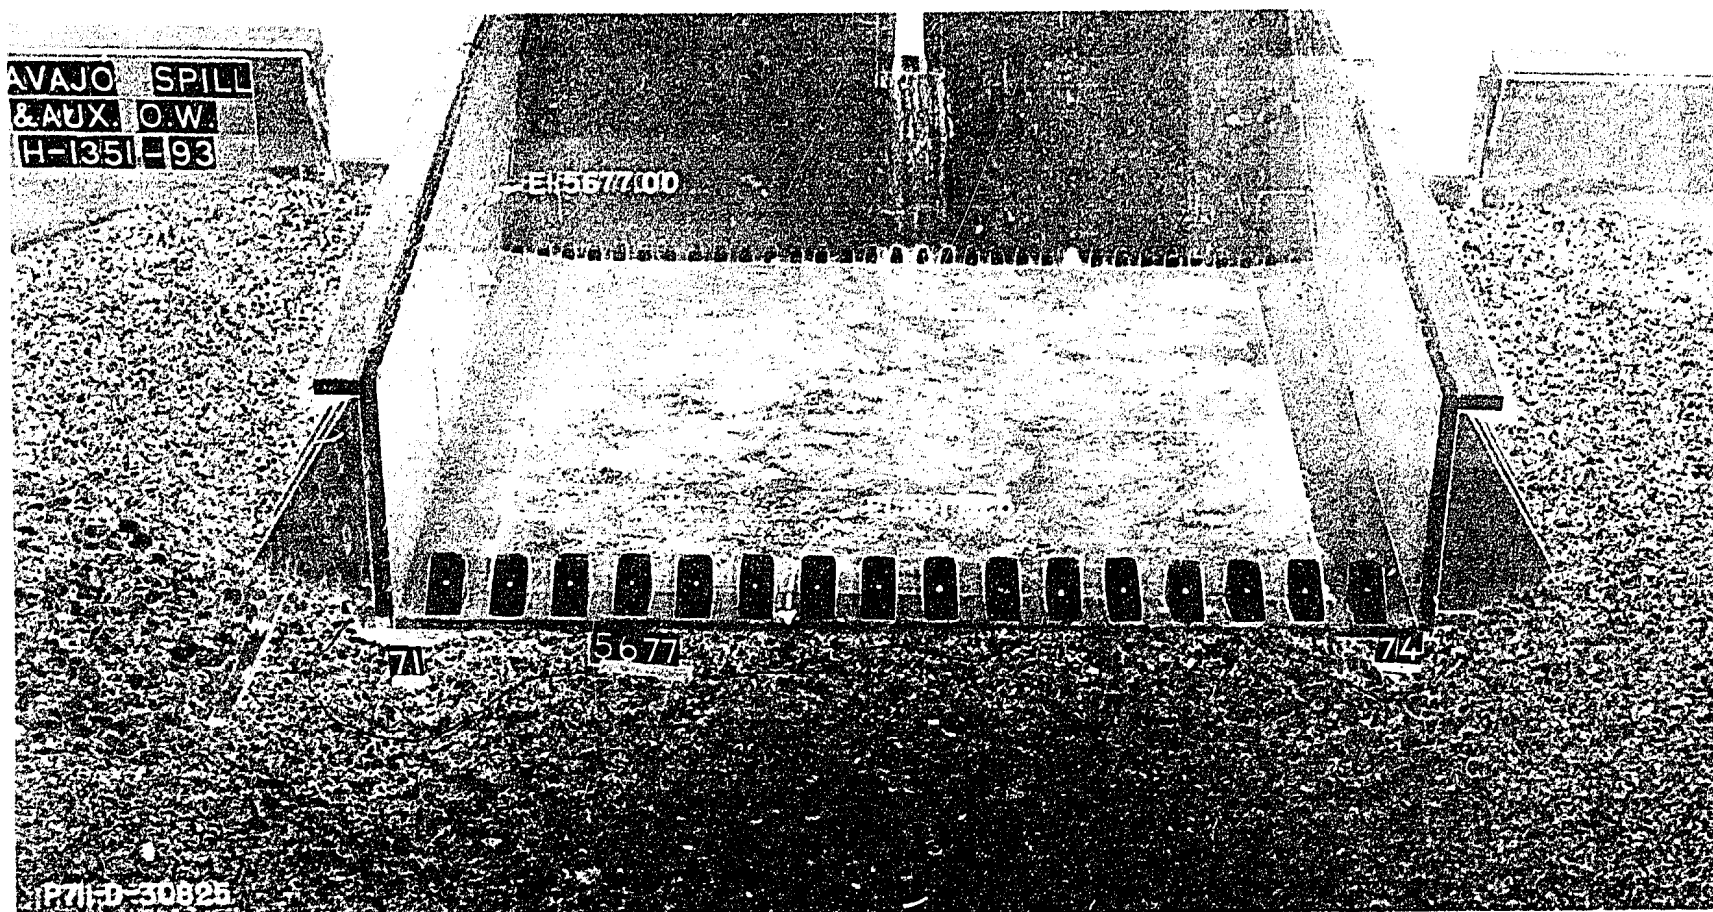
Scour after 4-1/2 hour test, 34,000 cfs, tailwater elevation 5723.

NOTE: Test conditions as described in Figure 37.

NAVAJO DAM SPILLWAY  
Erosion Test--Preliminary Basin  
With Riprap and Stabilized Right Bank  
1:48 Scale Model

Another erosion test was made to determine whether deeper scour would occur at the right corner of the basin if the right bank was stabilized to prevent material from sloughing into the eroded area. Larger stones were placed on the bank near the right-hand corner of the basin and a 3-inch-wide board was placed on edge in the bank, as shown in Figure 38. After a 4-1/2-hour model test, the eroded hole at the right-hand corner was 2 feet deeper than in the previous test (compare Figures 37B and 38). Because of the increased erosion depth, it was decided that the preliminary design should be improved.

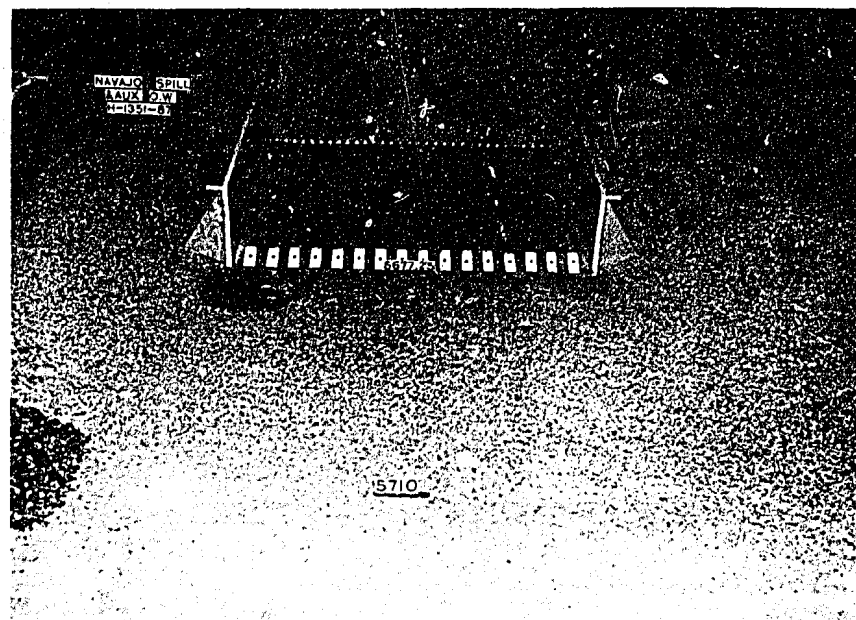
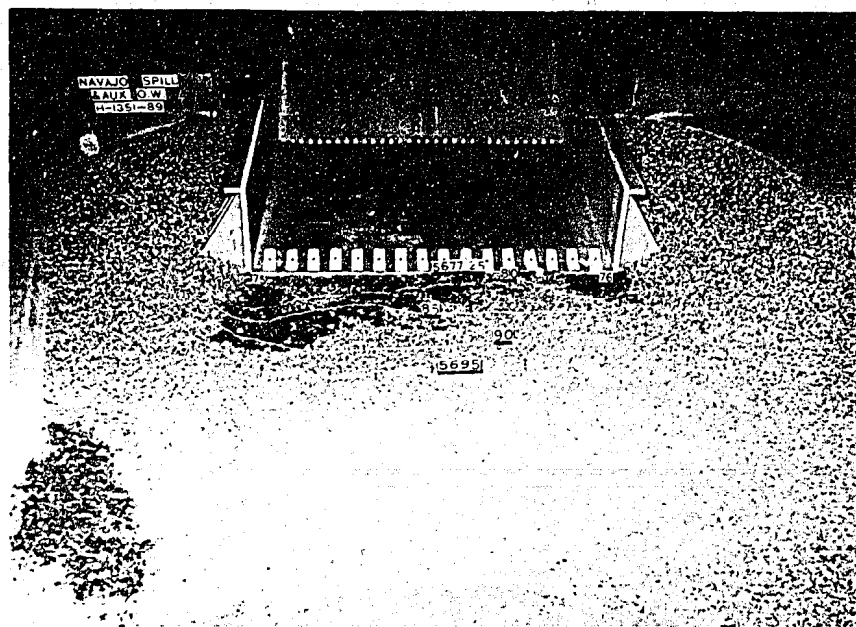
A. Before test.

B. Scour after 4 1/2-hour test 34,000 cfs,  
tailwater elevation 5715.

NOTE: Test conditions as described in Figure 37.  
Dark areas are larger stones up to 4 feet  
prototype size.

NAVAJO DAM SPILLWAY  
Erosion Test Using Larger Riprap  
1:48 Scale Model

The first step to obtain improvement was to place larger stones (up to 4 feet in prototype) near the corners of the stilling basin and at the downstream curve in the right bank where scour was observed to begin before progressing upstream. After 4-1/2 hours of operation at 34,000 cubic feet per second with the tail water at elevation 5715, the extent and depth of erosion at the corners were about the same as in the preliminary arrangement (Figures 37C and 39B). Nevertheless, it was logical to believe that heavier stones would better resist movement by larger flows than would smaller stones; therefore, the use of larger stones at the corners of the basin was recommended (Figure 40). It was interesting to note that the stones at the corners of the basin were carried downstream and then upstream toward the center of the basin end sill, as shown by the location of the large dark colored stones in Figure 39B.

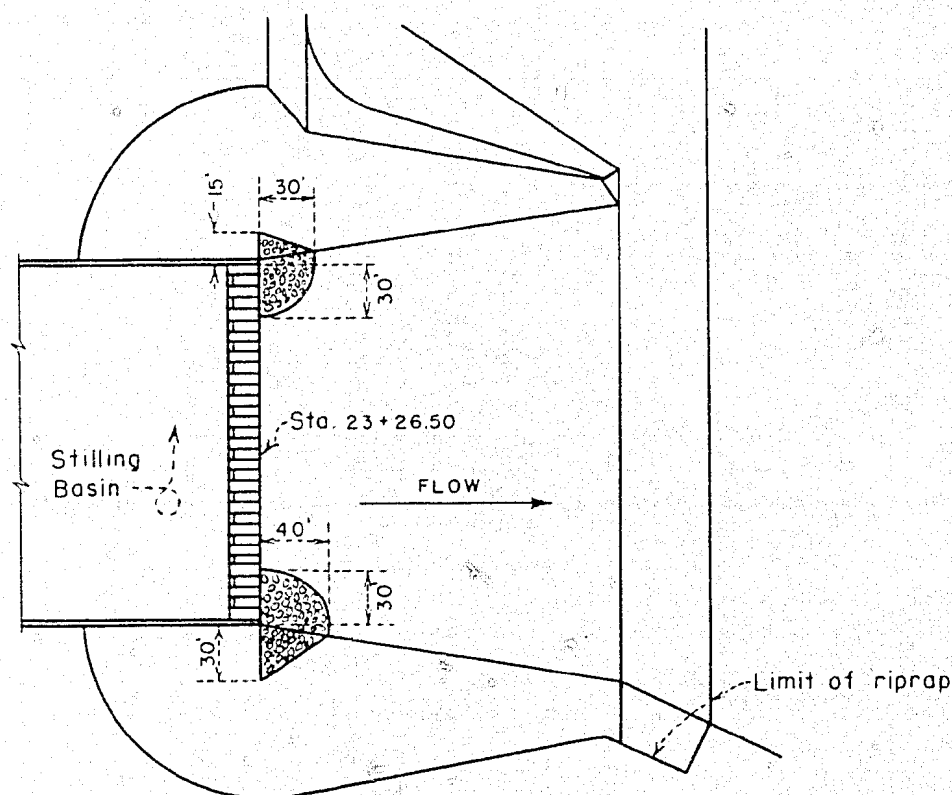
In the areas indicated at the corners of the stilling basin, it is recommended that extra heavy riprap be used. The size of the stones used should be from 2 to 4 feet in dia. or larger.

# NAVAJO DAM SPILLWAY RECOMMENDED RIPRAP ARRANGEMENT

1:48 SCALE MODEL

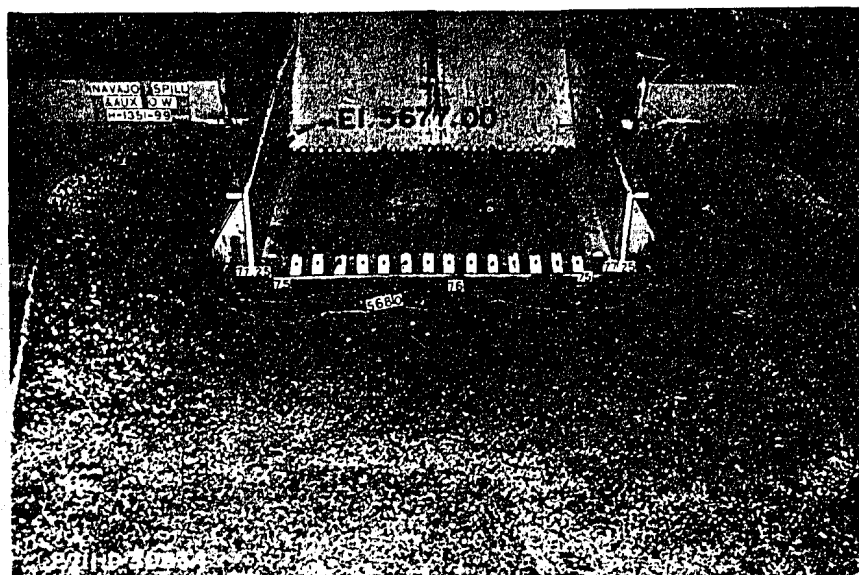
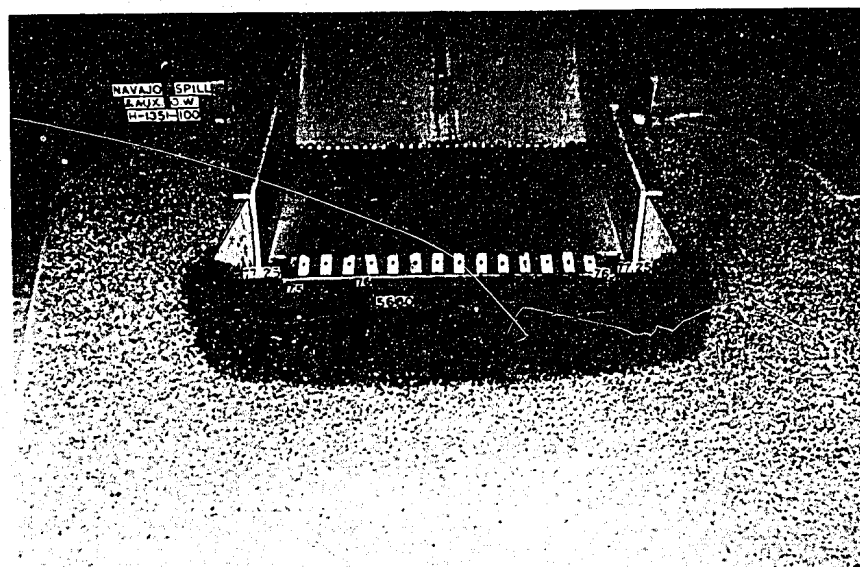
A. Tailwater elevation 5723.

B. Tailwater elevation 5715.

NOTE: Recommended sill is the preliminary 6:1 sloping  
sill with the slope in each end slot increased to 2:1.

4-1/2-hour tests, 34,000 cfs

NAVAJO DAM SPILLWAY  
Erosion Tests With Recommended End Sill  
1:48 Scale Model

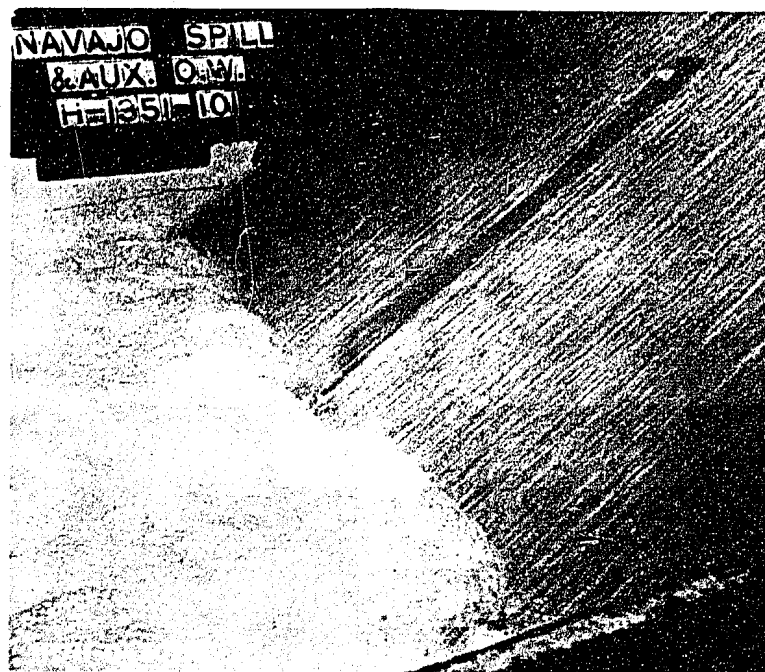
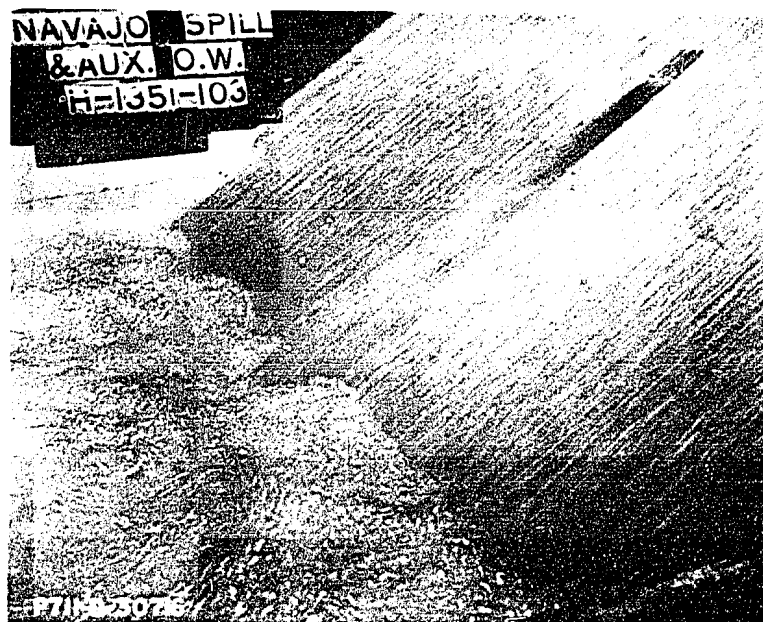
A. Spillway 34,000 cfs.  
Auxiliary outlet works no flow.  
Tailwater elevation 5719.

B. Spillway 32,000 cfs.  
Auxiliary outlet works 2,000 cfs.  
Tailwater elevation 5719.

NAVAJO DAM SPILLWAY  
Spillway Discharging Over Auxiliary Outlet Works Junction  
1:48 Scale Model

The auxiliary outlet works is designed to discharge 2,010 cubic feet per second at a velocity of 83 feet per second, flowing 4-feet deep at Station 19+54; and 1,850 cubic feet per second at a velocity of 45 feet per second flowing approximately 7.1 feet deep. The hydraulic characteristics of the flow for these operating conditions were very satisfactory (Figures 44 and 45). The spillway flow passed over the auxiliary junction outlet works quite smoothly when the auxiliary outlet works was not operating (Figure 44A), but some splash occurred as a result of the spillway flow striking the trajectory curve of the outlet works tunnel floor. The flow passing over the outlet works junction acted as an ejector to draw a considerable amount of air from the auxiliary outlet works tunnel which was vented to the atmosphere immediately downstream from the control gate. When the vent was closed, the lowered pressure in the tunnel caused water from the spillway flow to partially fill the tunnel portal. Therefore, it is recommended that the auxiliary outlet works be vented during spillway operation, as well as during operation of the outlet works.

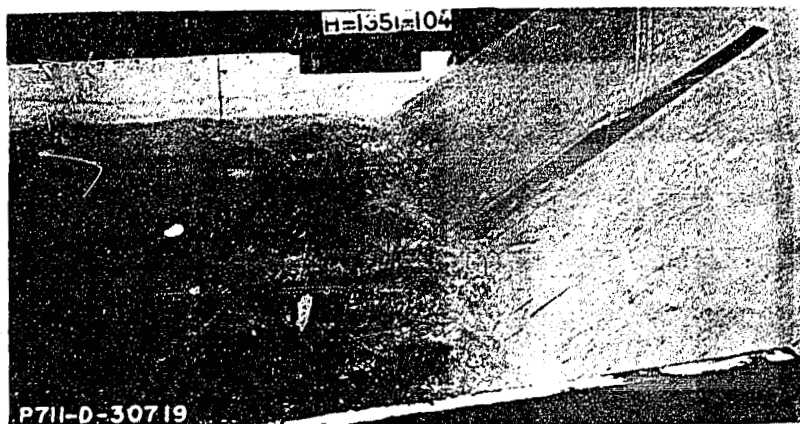
A. Auxiliary outlet works 2,000 cfs.  
Spillway 2,000 cfs, T.W. elevation 5710.

NAVAJO DAM SPILLWAY  
Auxiliary Outlet Works Discharging  
1:48 Scale Model

The preliminary junction of the auxiliary outlet works with the spillway chute shown in Figures 3 and 6, was tested and found to be satisfactory. It was, therefore, recommended for the final prototype design.

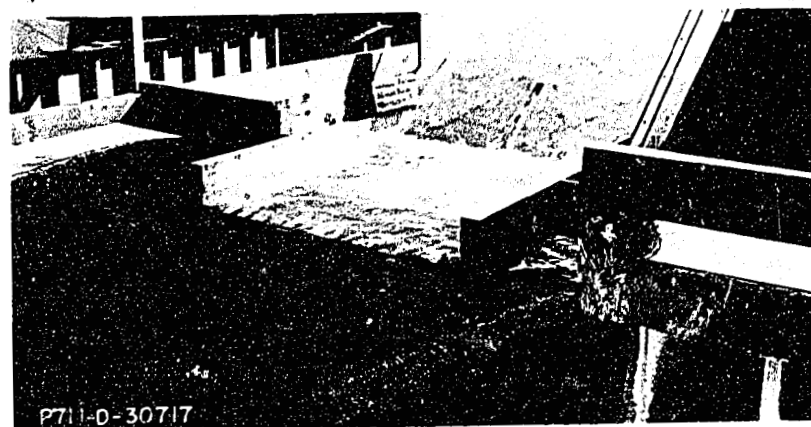
B. Same as A.

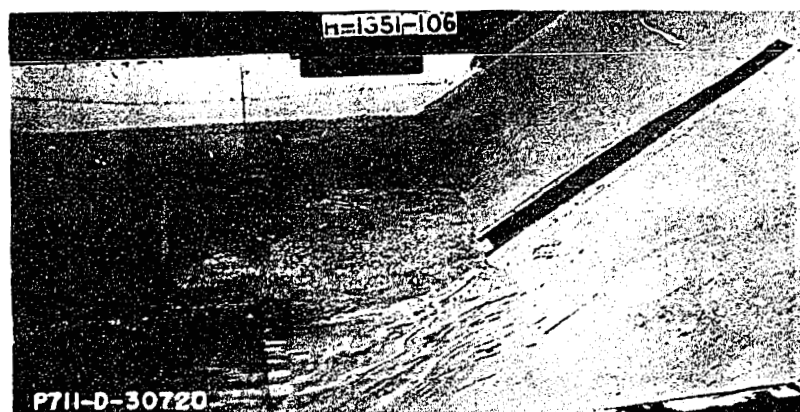
C. Auxiliary outlet works 1,800 cfs.  
Portal depth 7 ft 0 in.  
Spillway no flow, T.W. elevation 5709.

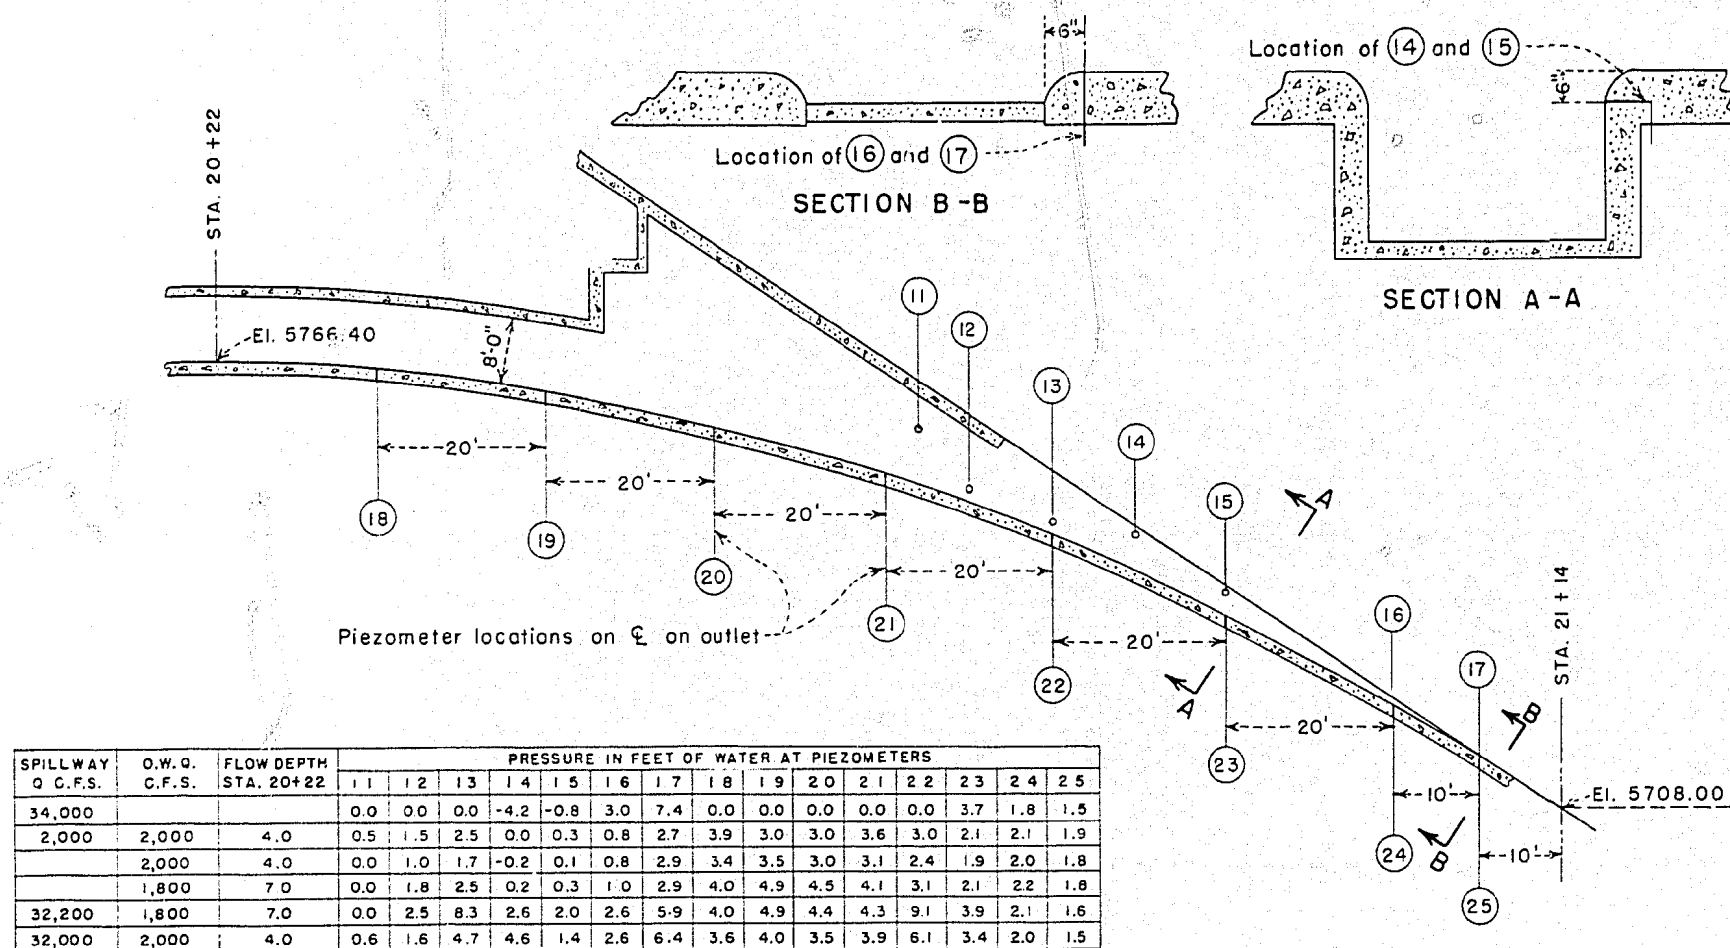
All Pressures are atmospheric unless noted.  
Zero pressure is atmospheric pressure.

Note: Recommended hump in chute
